**REPORT NUMBER: NCAPSIDE-MGA-2004-005**

**NEW CAR ASSESSMENT PROGRAM  
SIDE IMPACT TEST**

**General Motors Corporation  
2005 Chevrolet Equinox  
NHTSA NUMBER: M50101**

**PREPARED BY:  
MGA RESEARCH CORPORATION  
5000 WARREN ROAD  
BURLINGTON, WI 53105**

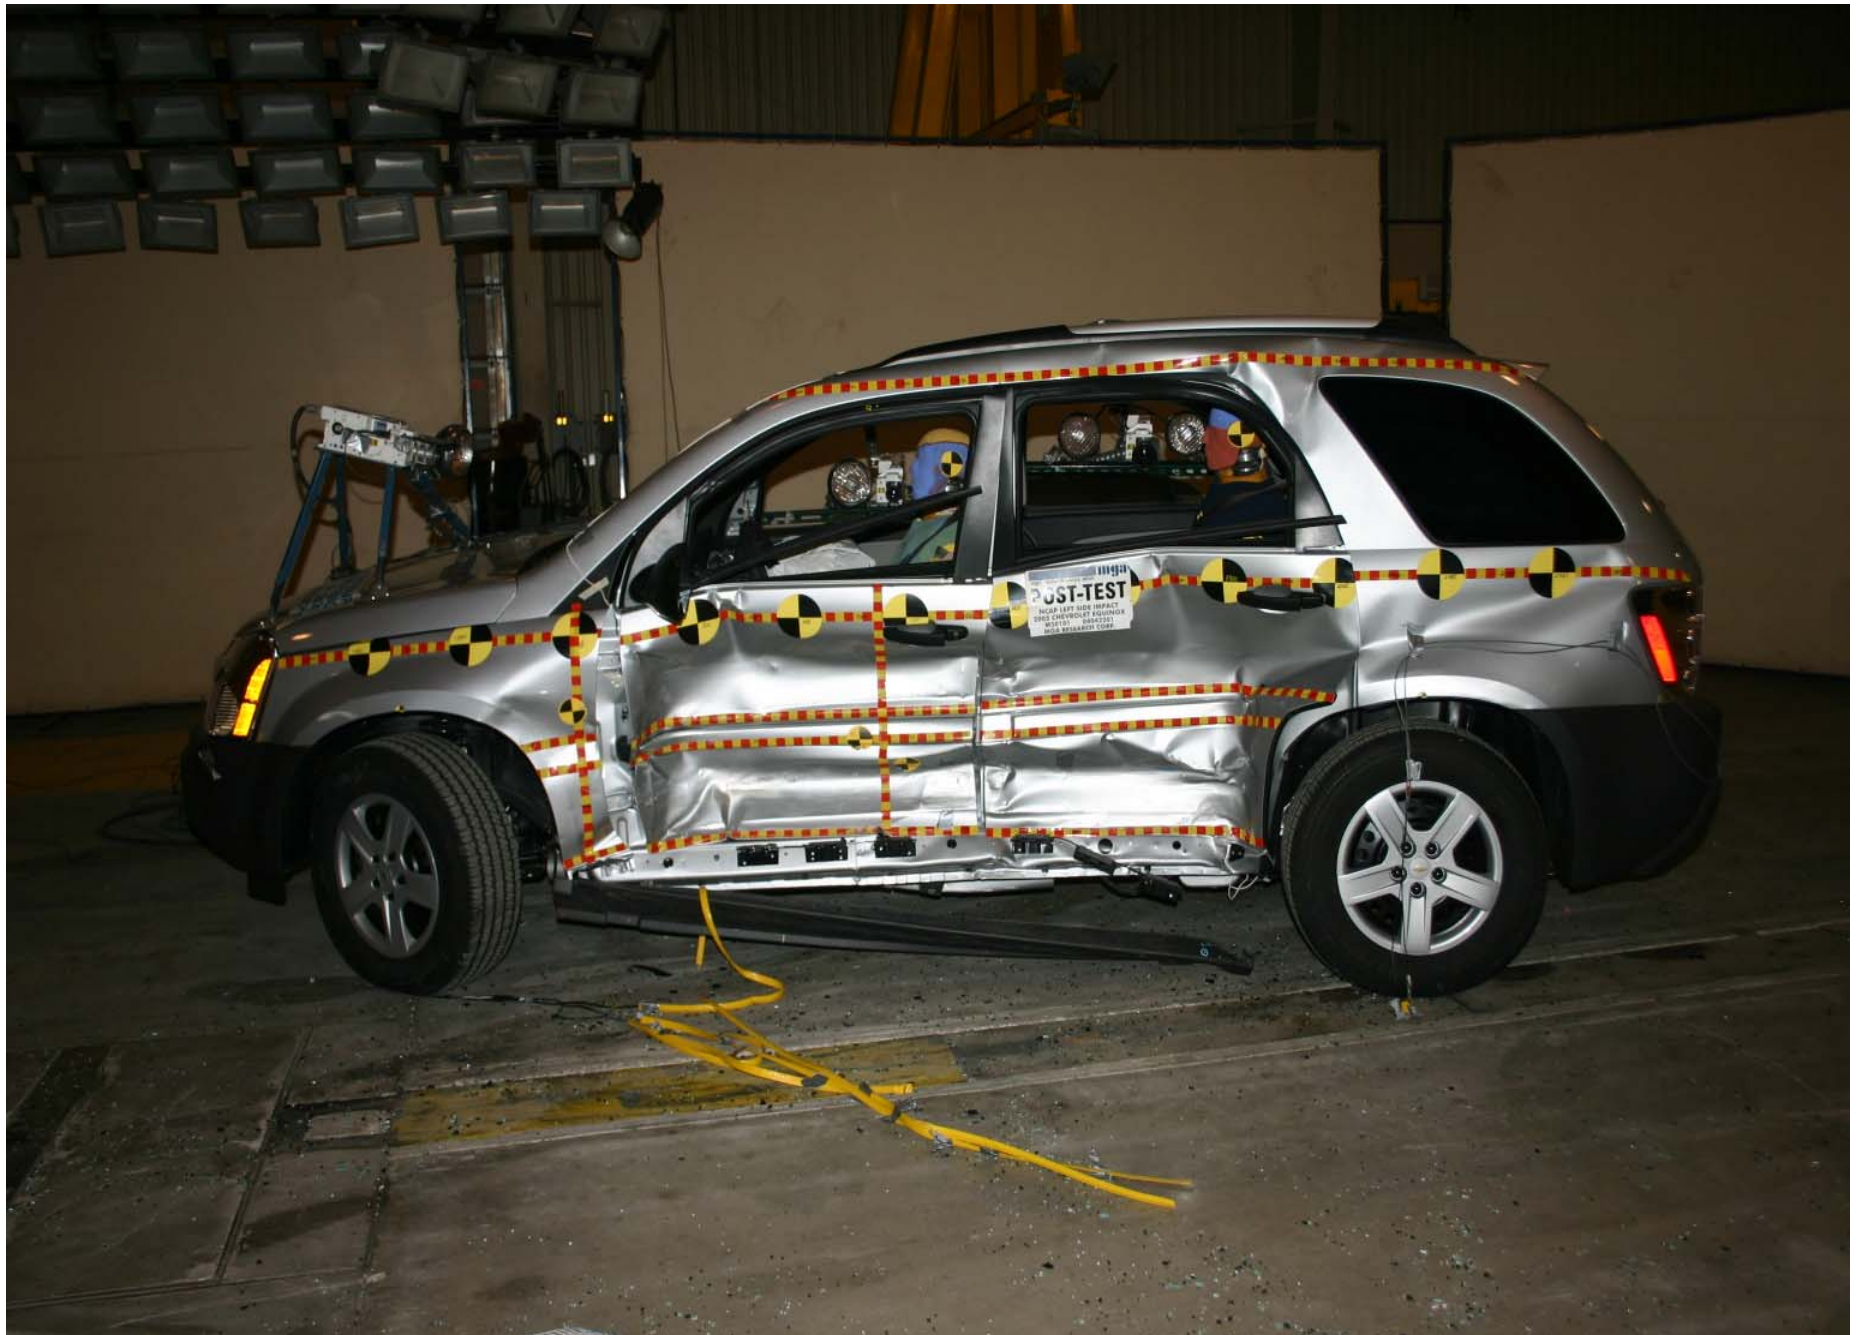
Post-Test Left Side View of Test Vehicle

Critical Areas of Performance	Observations and Conclusions
Pillar Performance	No Separation
Sill Separation	None
Windshield Damage	None
Window Damage	Left Front and Rear Broke
Other Notable Effects	Left driver and left rear passenger window broke.

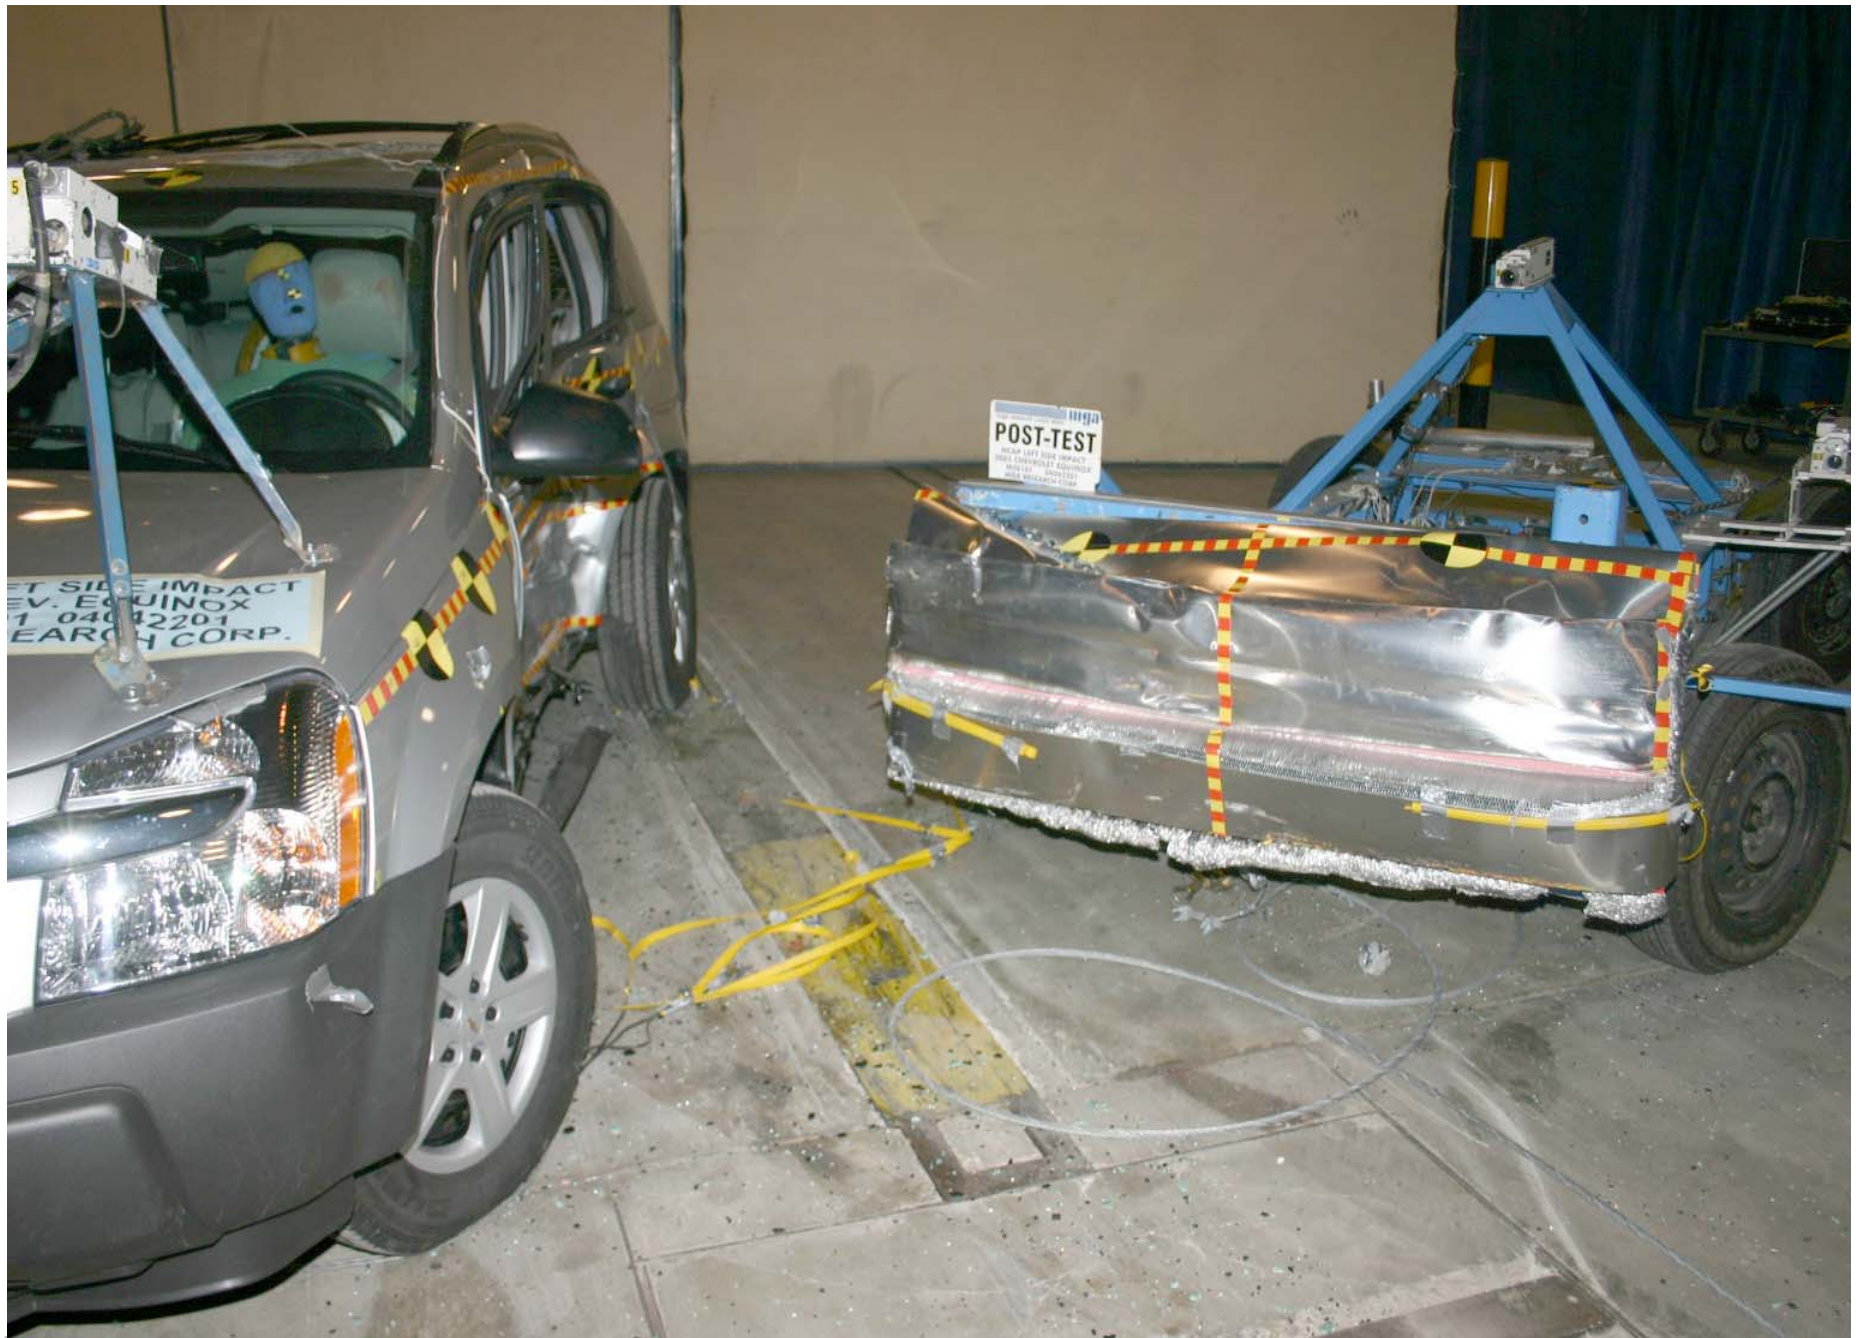
Post-Test MDB and Vehicle (Left Front View)

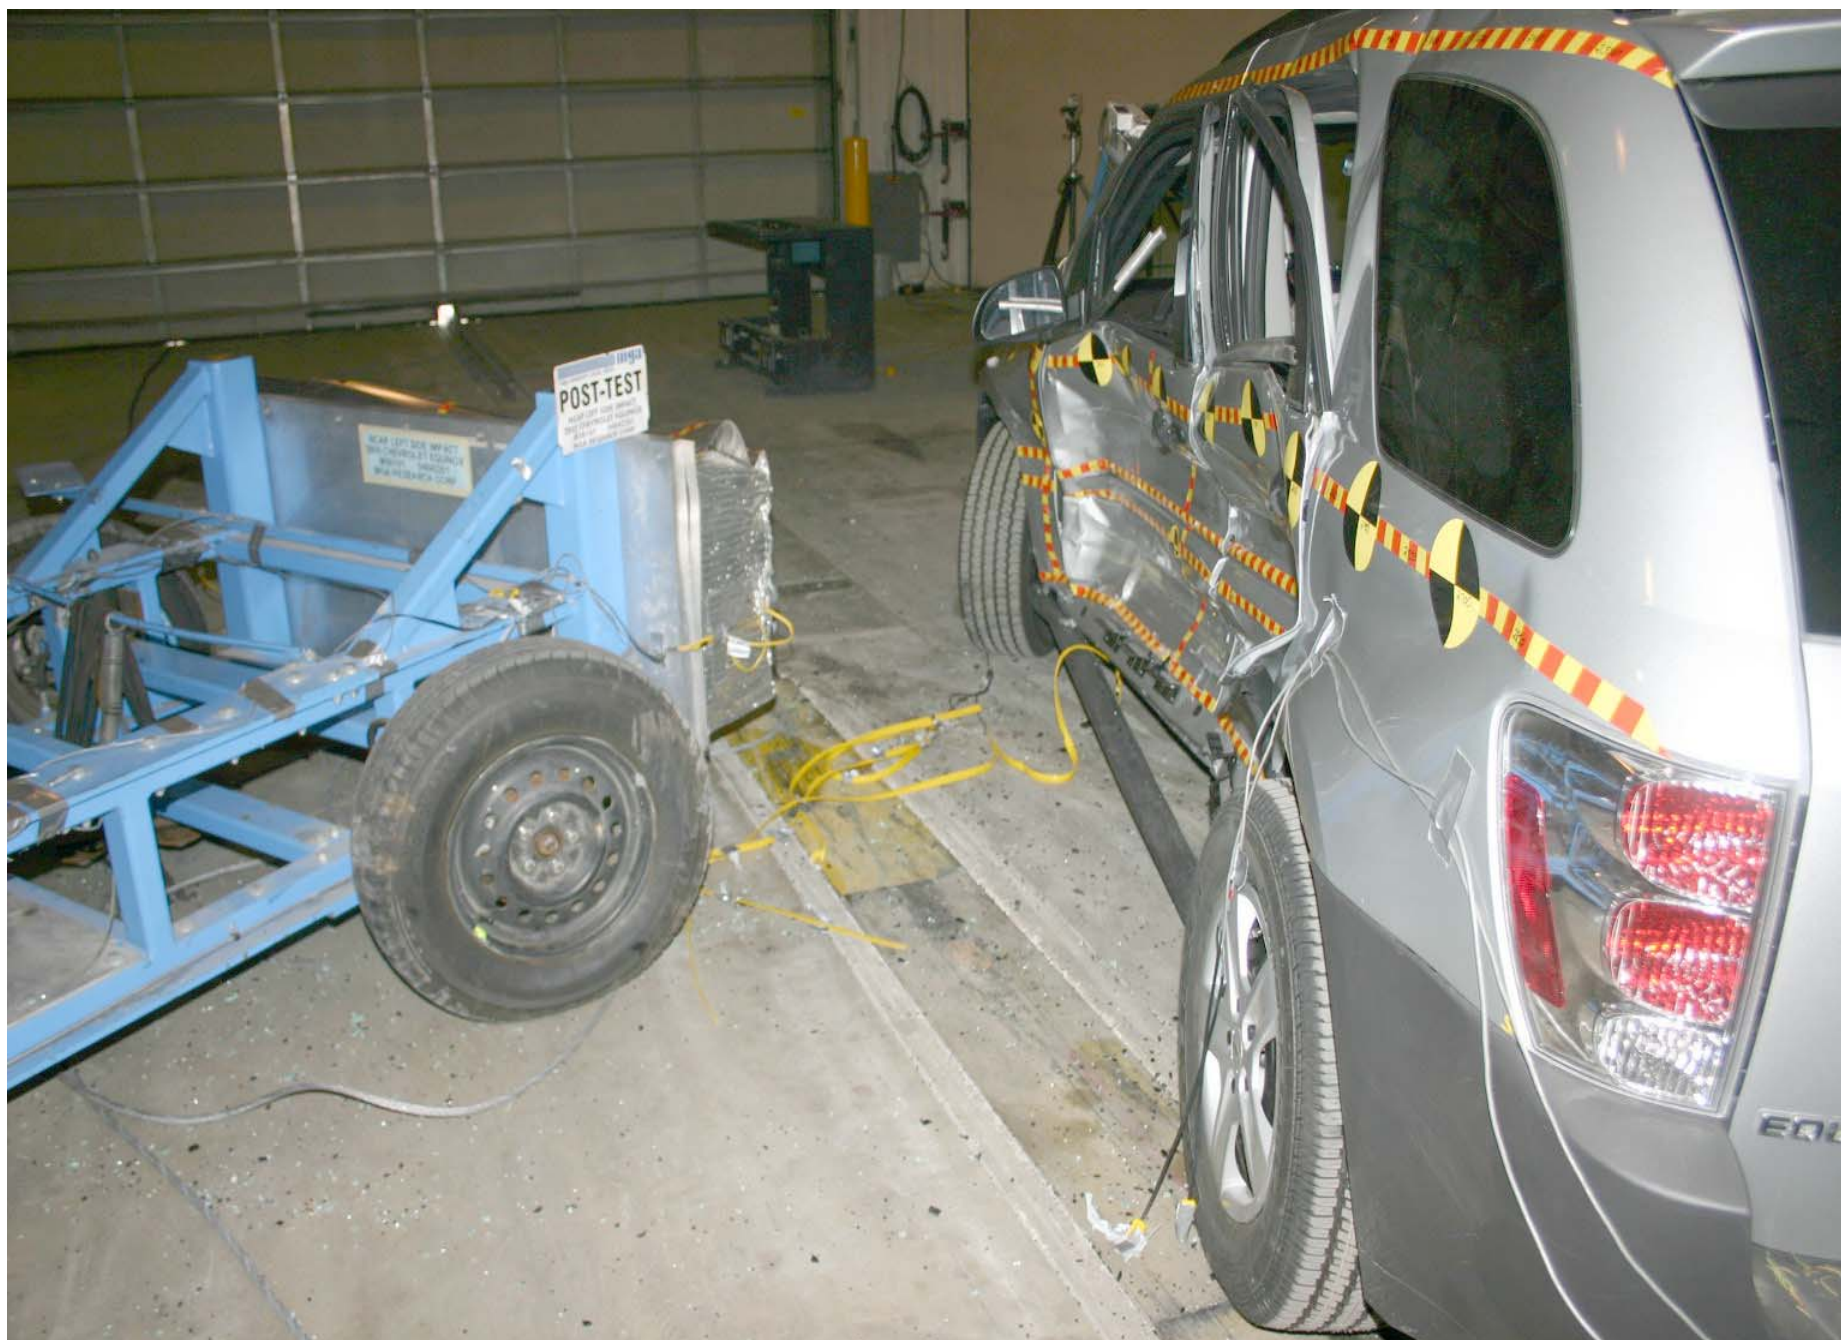
Post-Test MDB and Vehicle (Left Rear View)

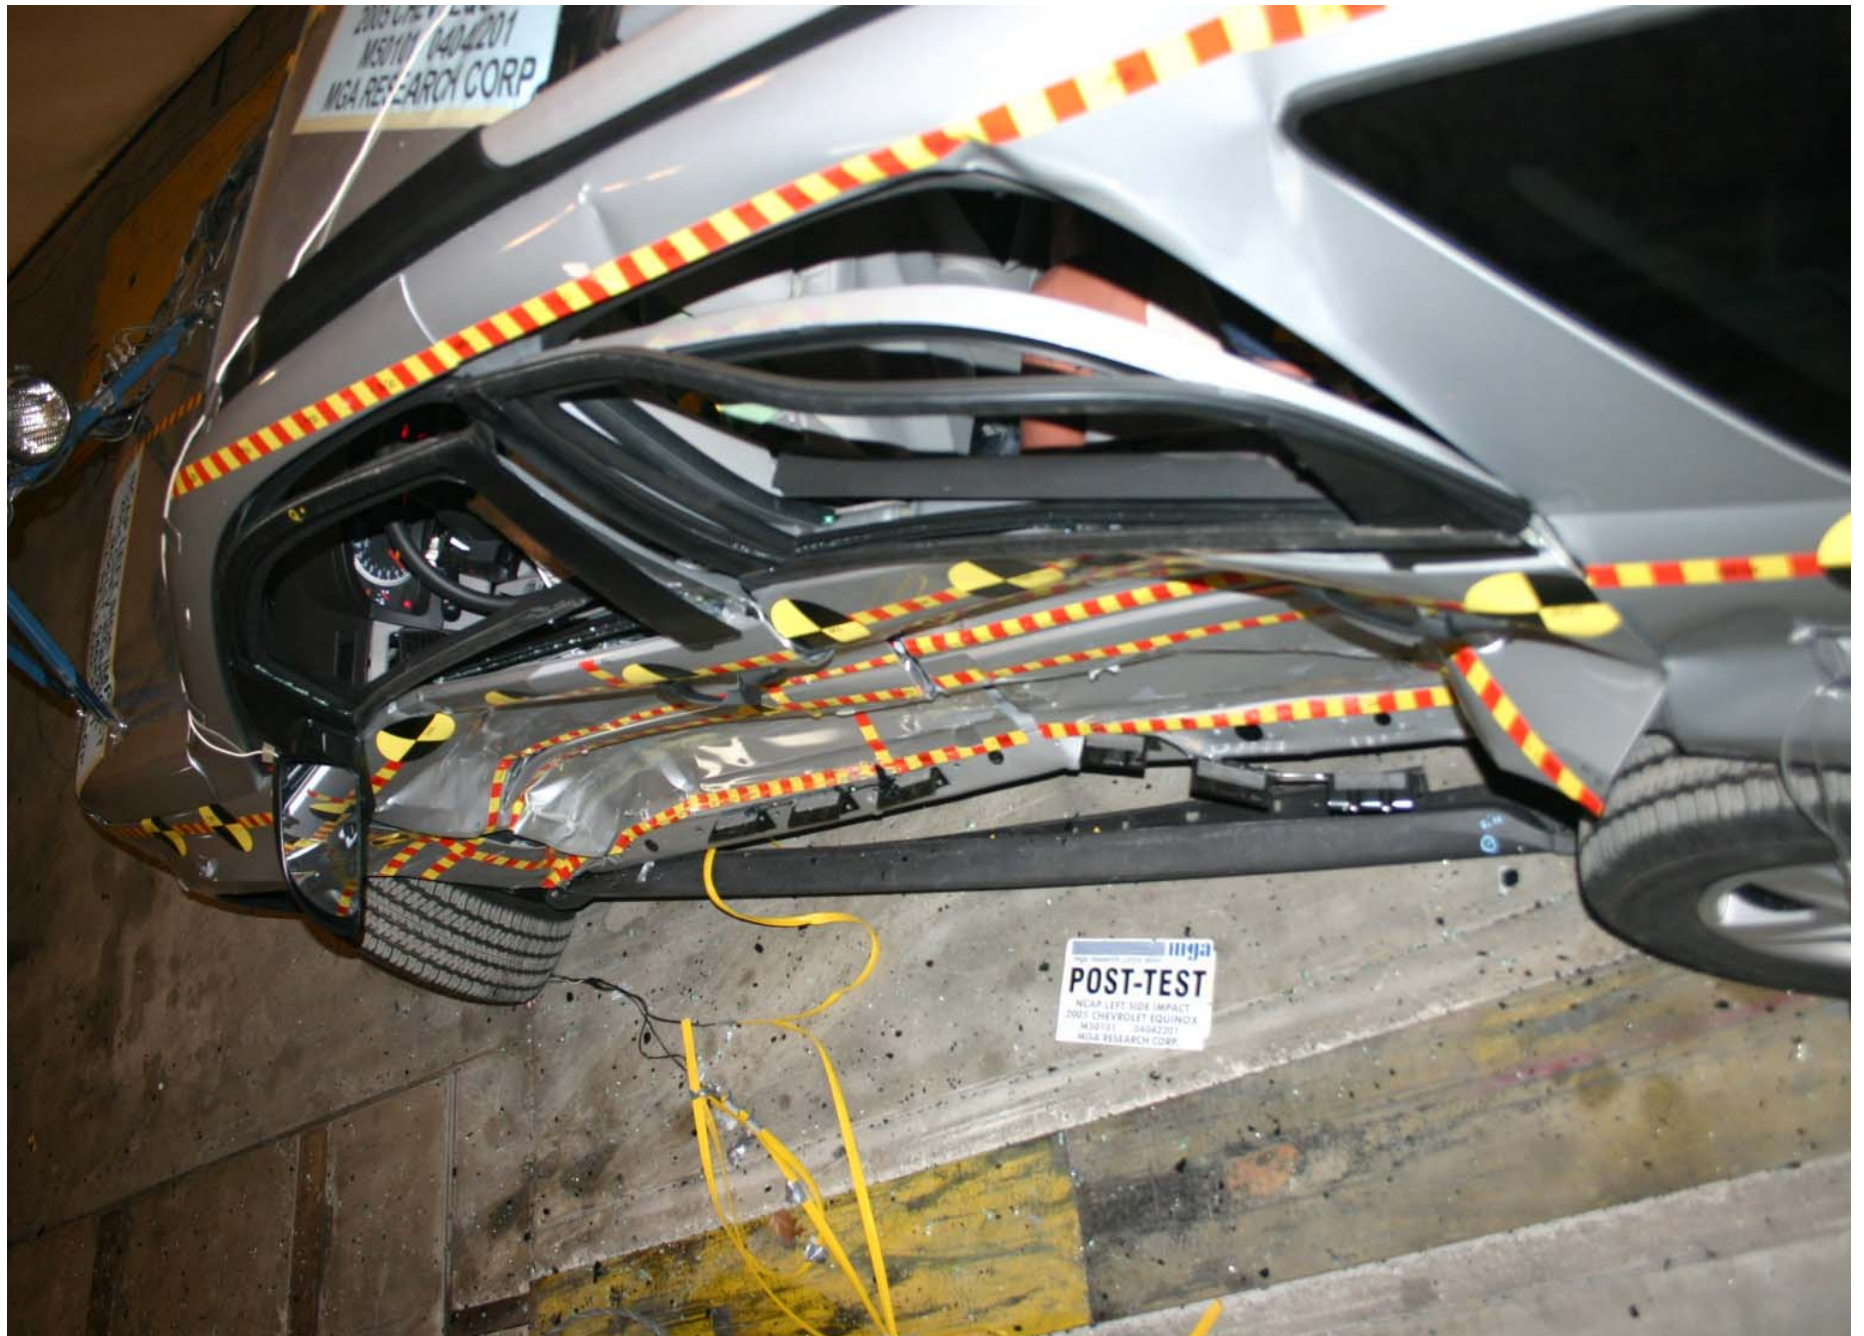
Post-Test Vehicle Overhead View

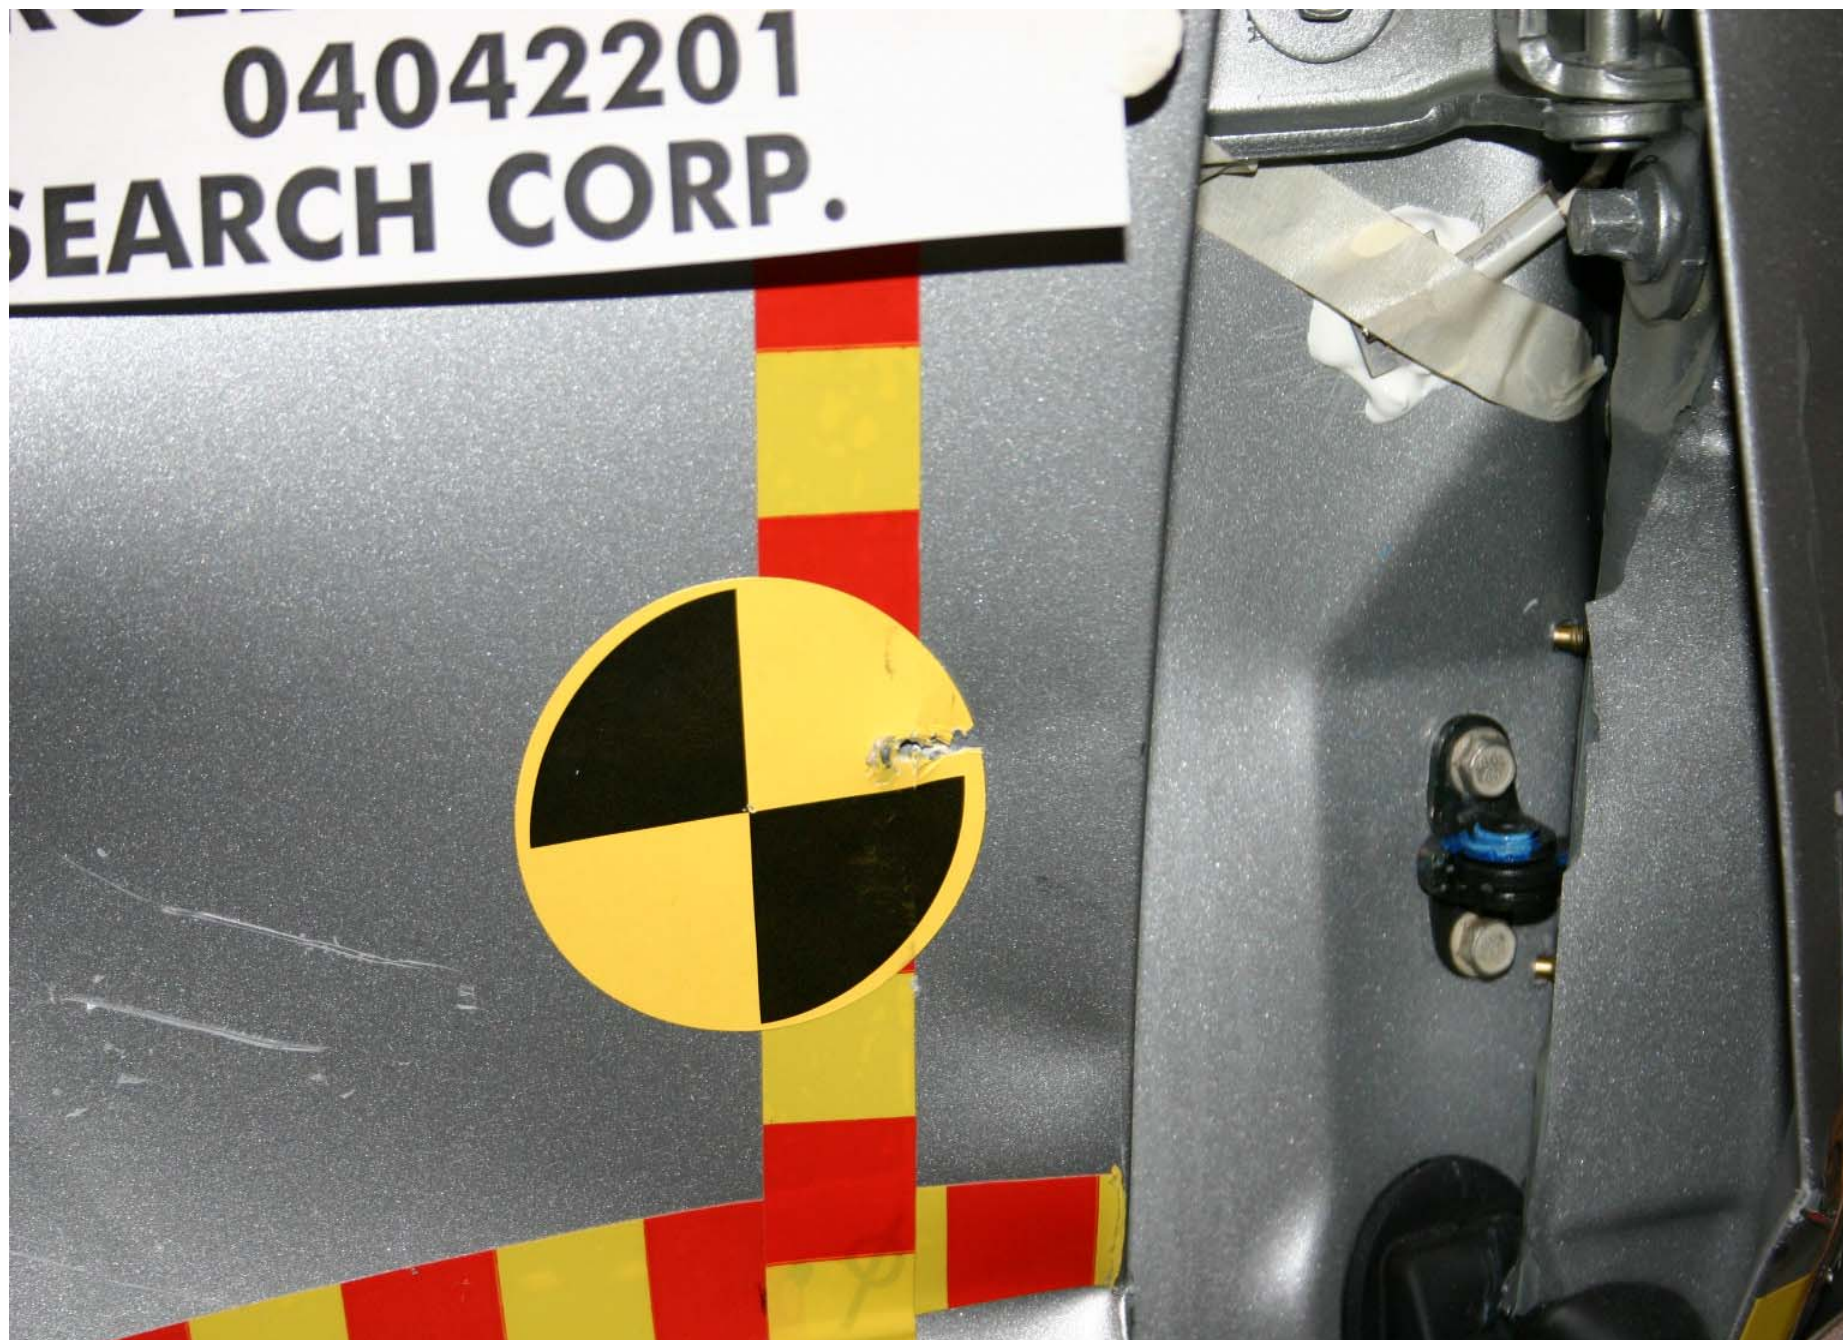
Post-Test Impact Point on Vehicle

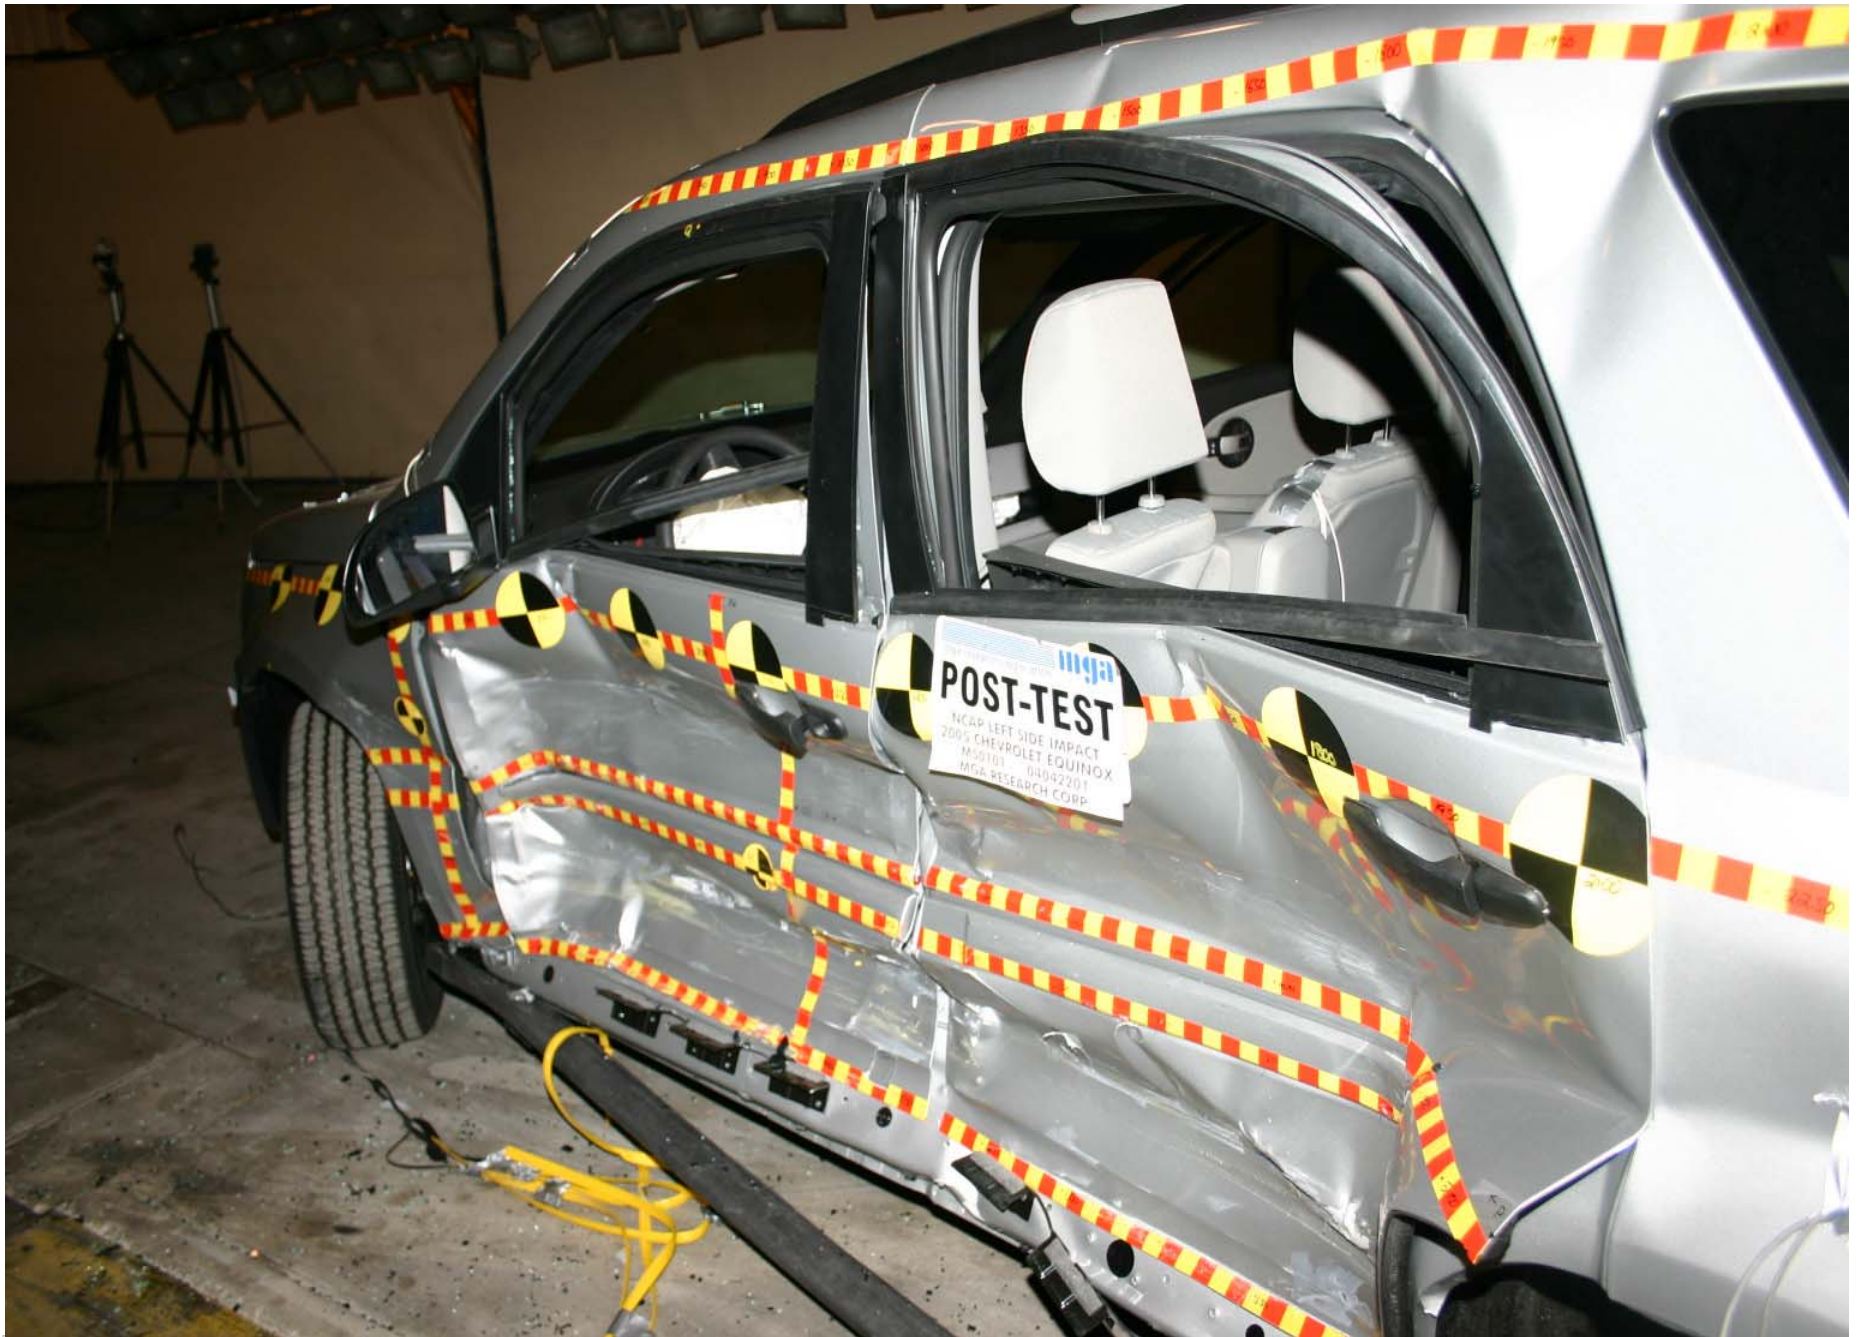
Post-Test Rear  $\frac{3}{4}$  View of Left Doors of Test Vehicle

Description	Front	Rear
Locked/Unlocked Doors	Doors were unlocked	Doors were unlocked
Left Side Door Opening	Door remained closed and latched	Door remained closed and latched
Right Side Door Opening	Door remained closed and latched; Door opened without tools	Door remained closed and latched; Door opened without tools
Seat Movement	0	0
Seat Back Failure	None	None

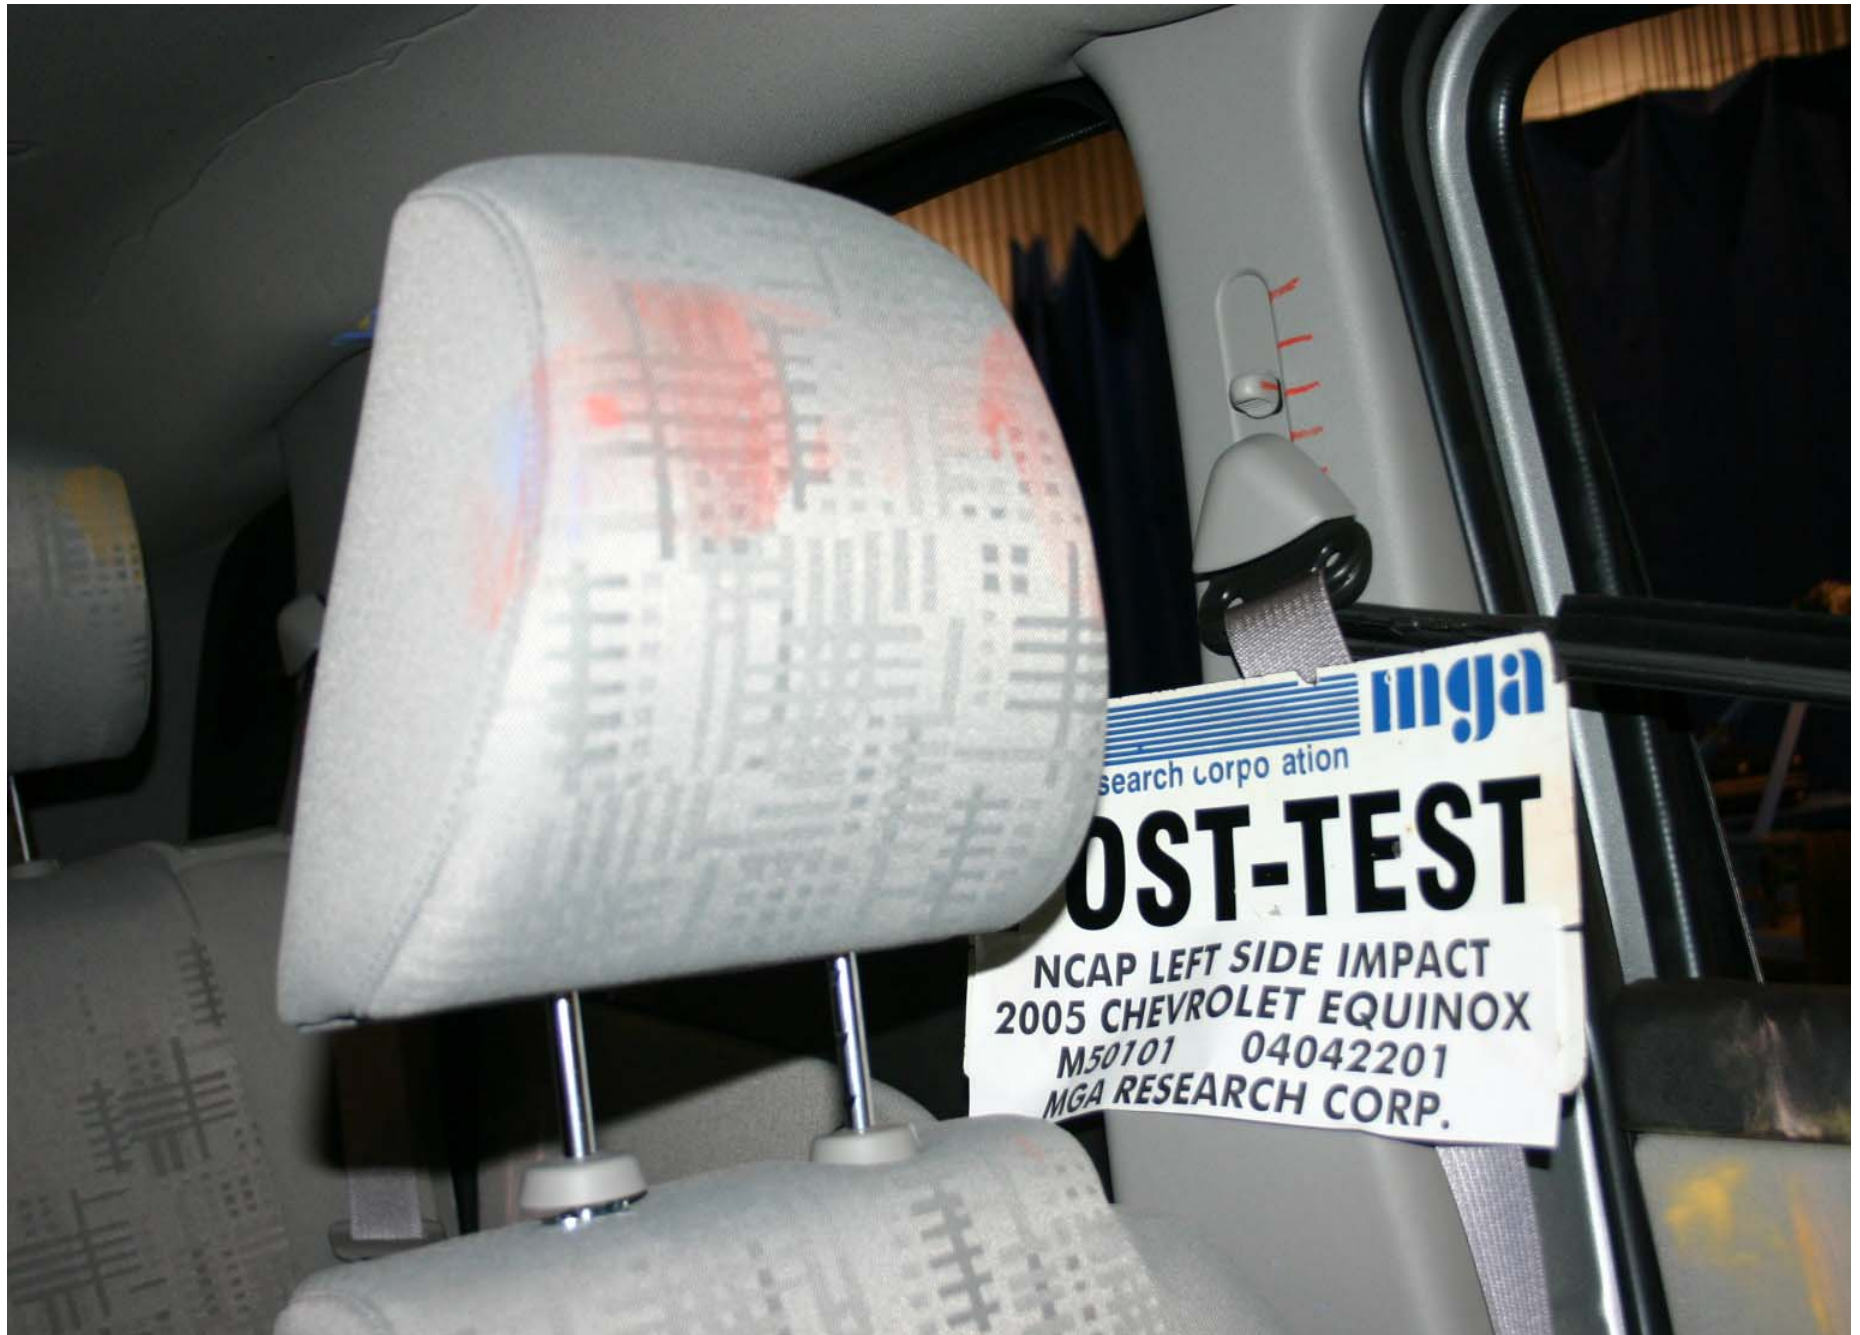
Post-Test Driver Dummy Head Contact

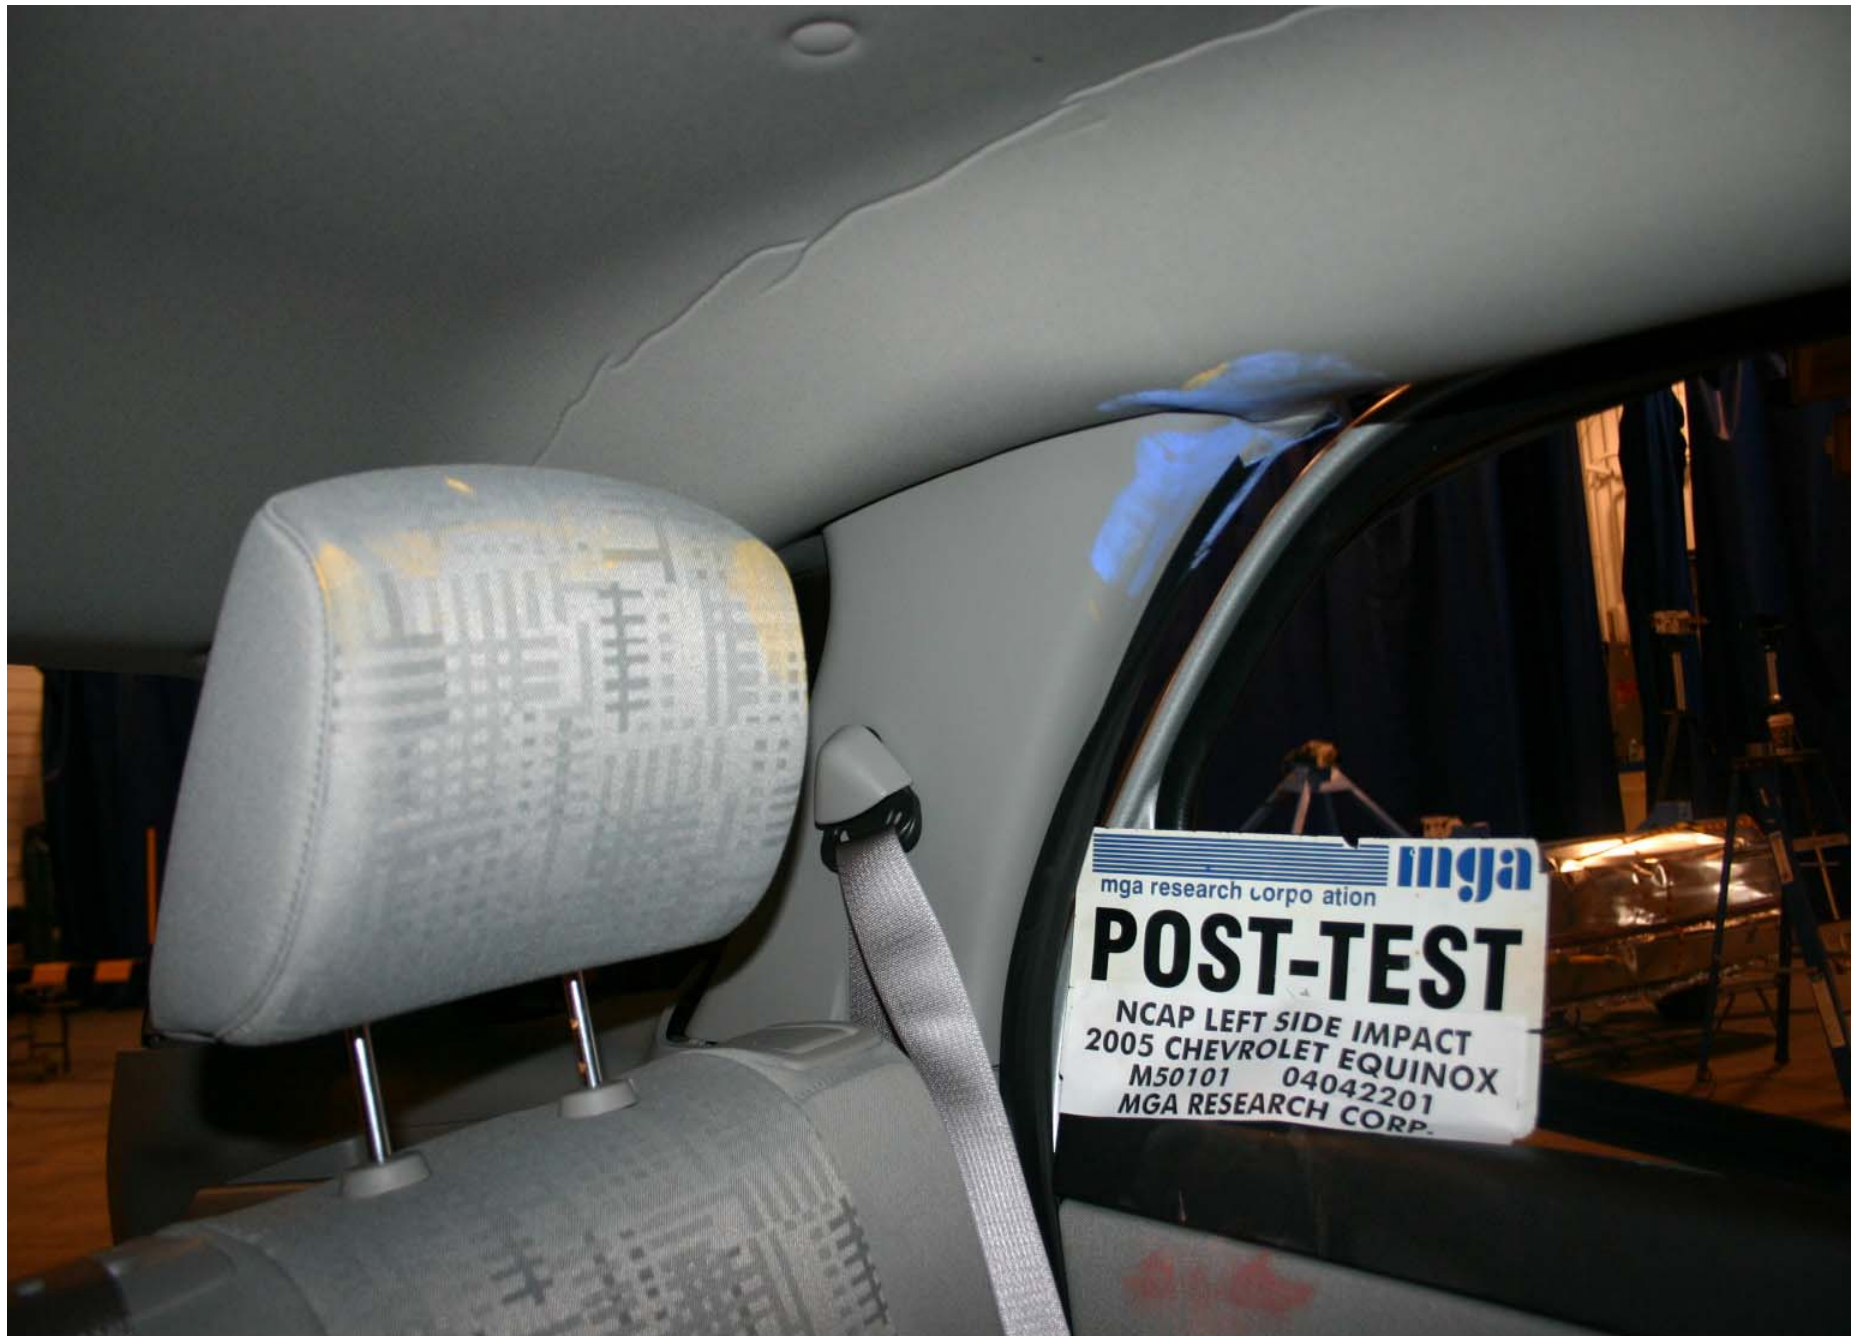
Post-Test Passenger Dummy Head Contact

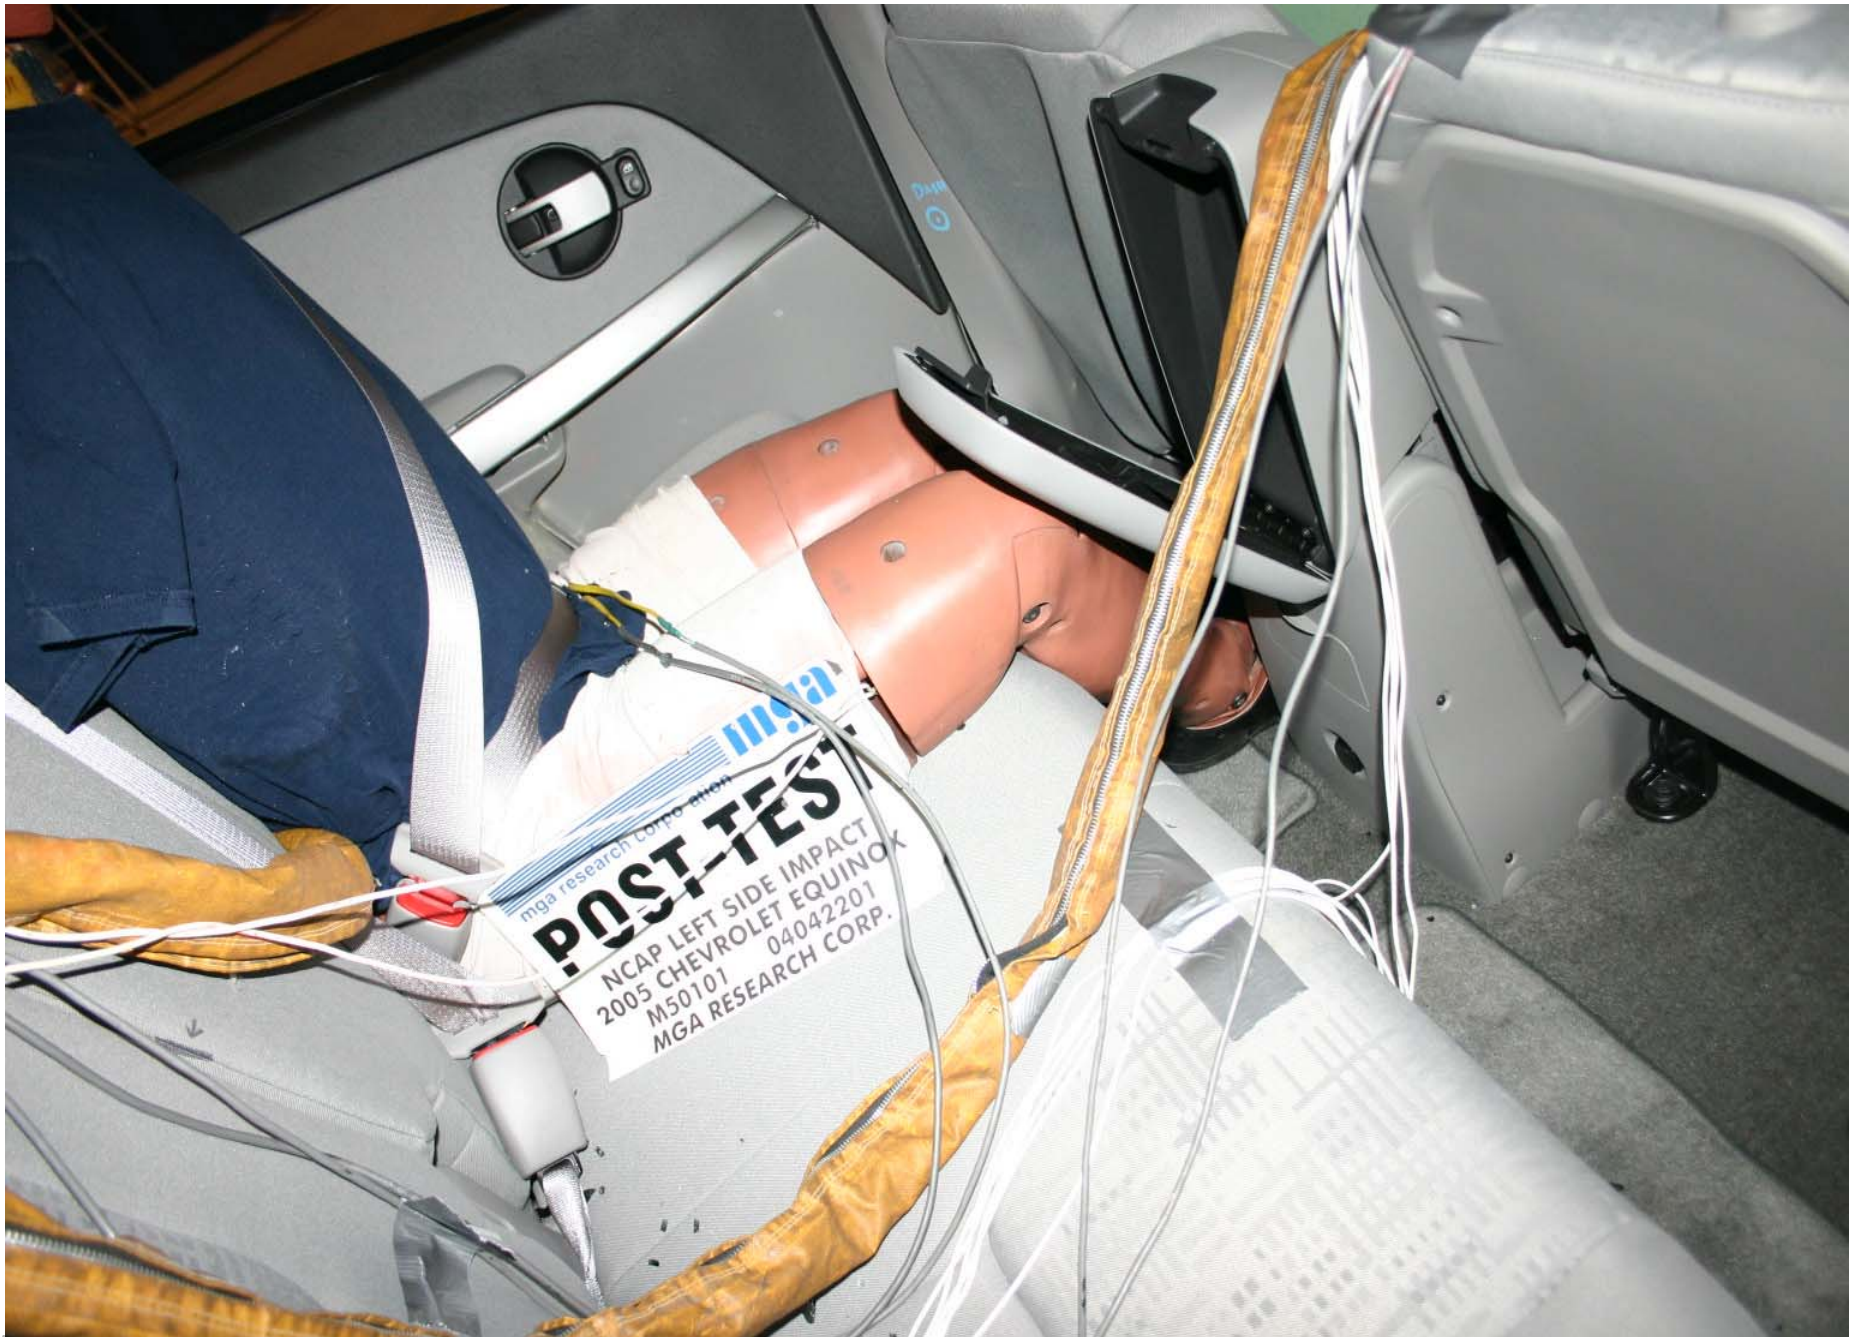
Post-Test Passenger Dummy Knee Contact
